Acromioclavicular Joint Reconstruction

Alan M. Reznik, M.D.
The Orthopaedic Group, LLC

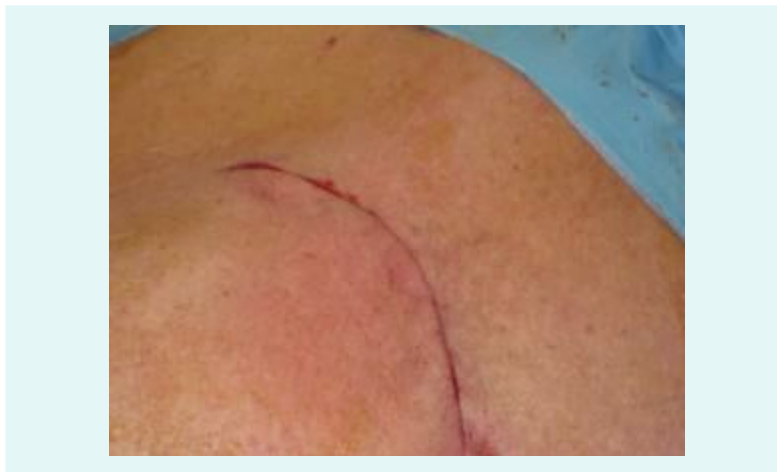
Figure 1: Shoulder Strap Incision - this is used because of the ability to extend the exposure if needed. It lies in the natural lines of the skin, making it a more cosmetic incision than would a transverse incision in this same location.

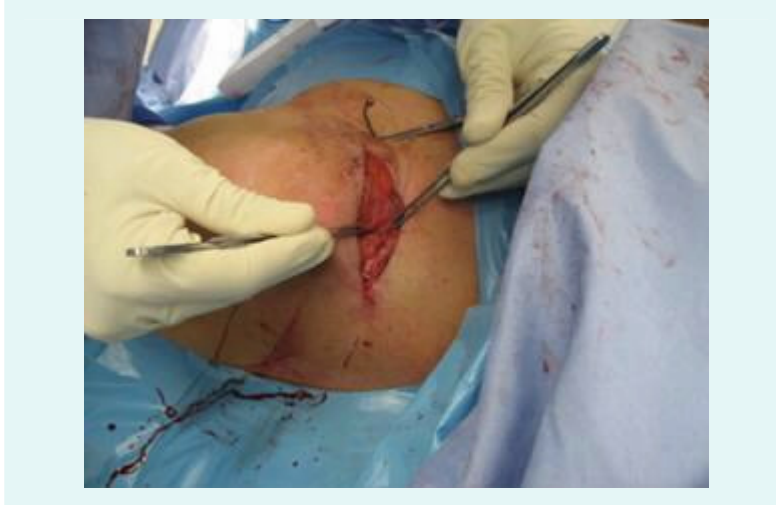
Figure 2: Developing the next layer the muscle/fascia plane of the deltoid and trapezius muscles.

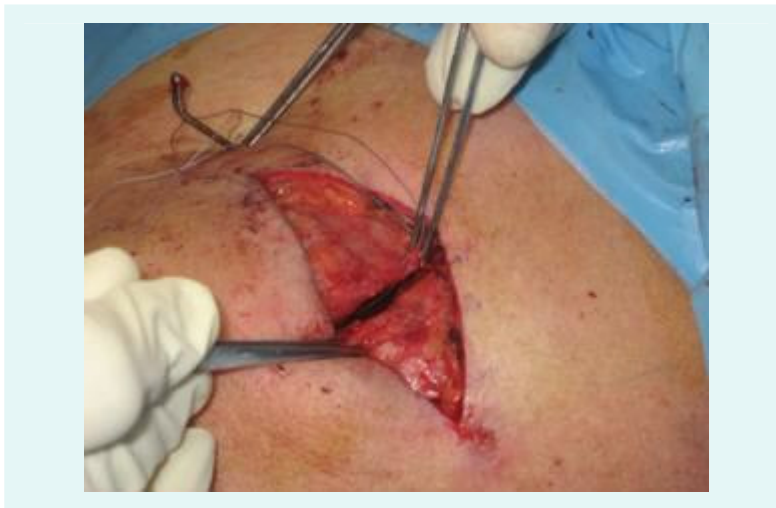
Figure 3: Exposing the clavicle (collar bone).

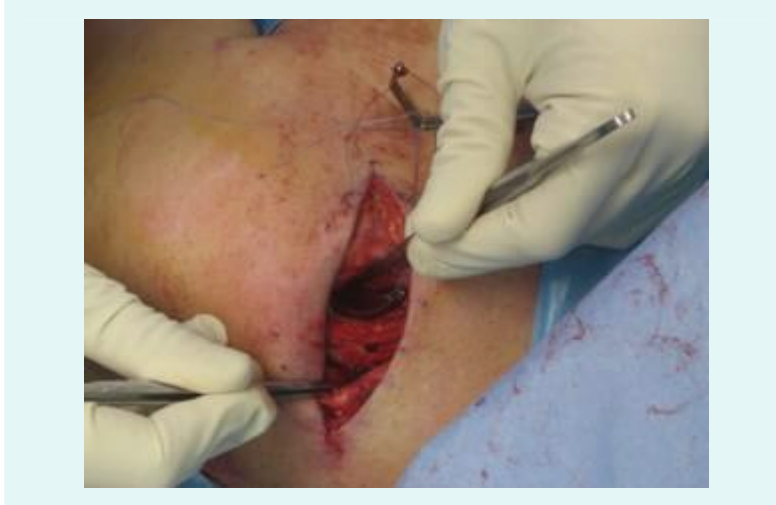
Figure 4: Seeing the edge of the unstable bone.

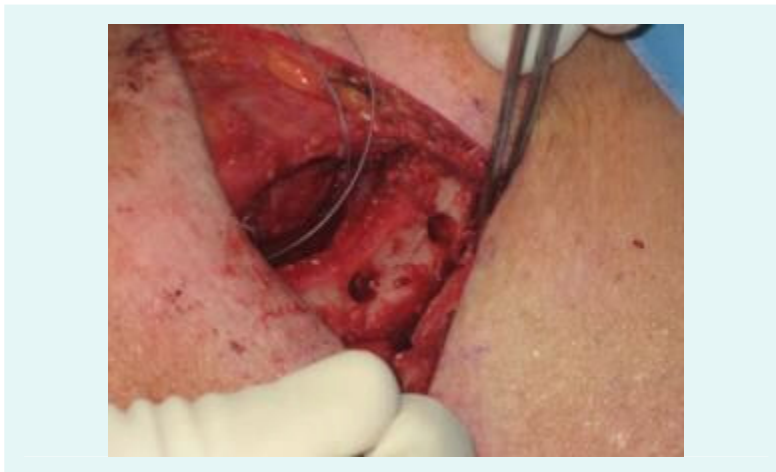
Figure 5: The holes have been drilled in the distal collar bone for the placement of the tendon graft after replacing the tone ligaments in their natural position around the coracoid process (not seen here) of the scapula (shoulder blade).

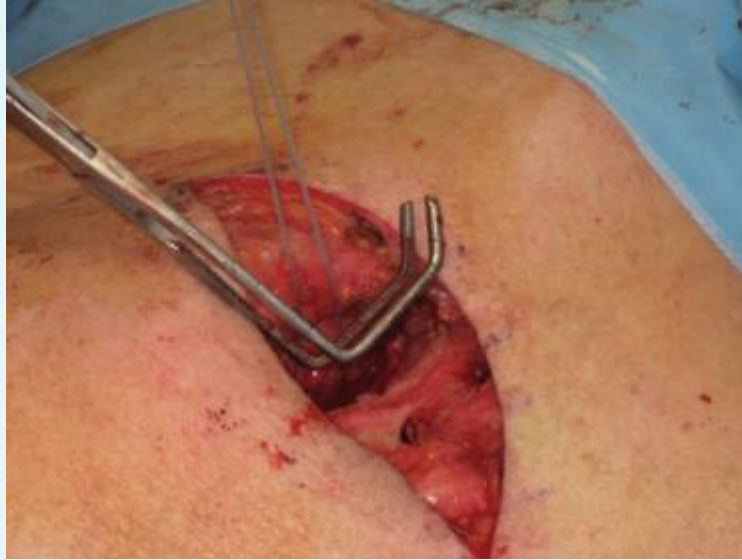
Figure 6: A special clamp, the Stedinsky Clamp (often used in open heart surgery) is used to pass the sutures around the coracoid process. These sutures aid in passing the actual tendon graft that has been prepared separately on the OR table for graft placement later in the procedure.

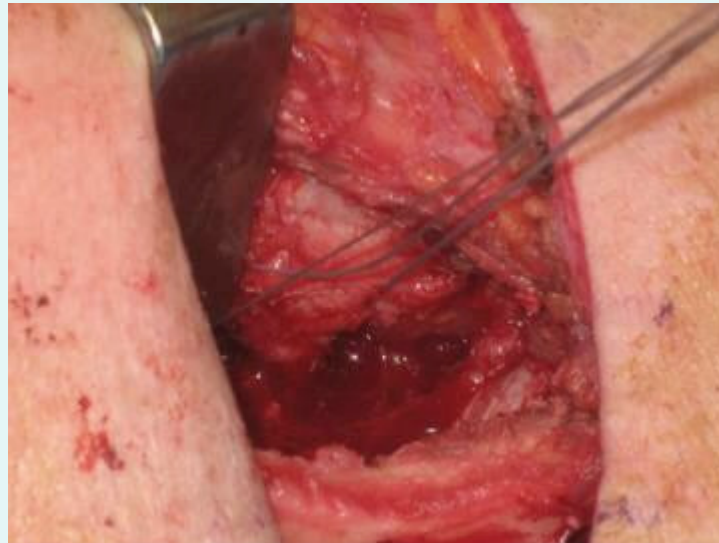
Figure 7: The guide sutures are passed prior to passing the graft.

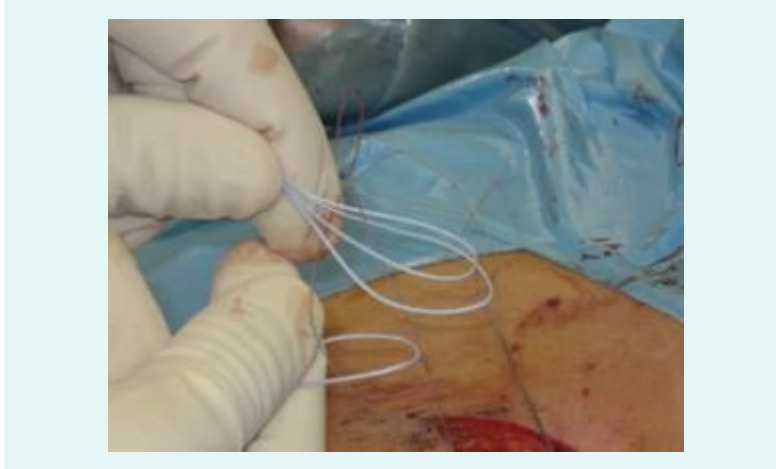
Figure 8: The suture loops that are attached to the leading ends of the graft are passed through the guide sutures.

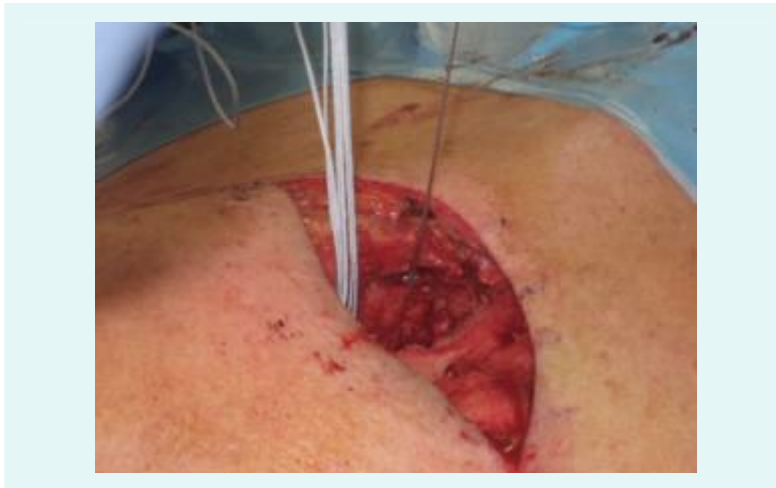
Figure 9: These loops are then passed under the coracoid process.

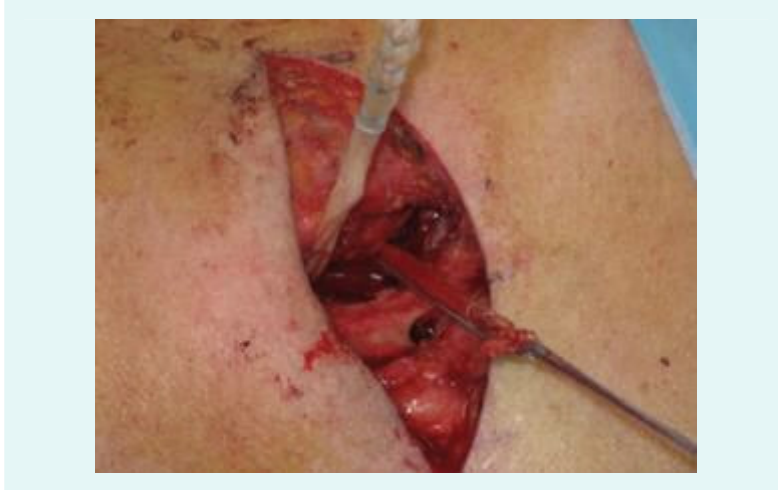
Figure 10: The graft follows the loops under the tip of the coracoid process.

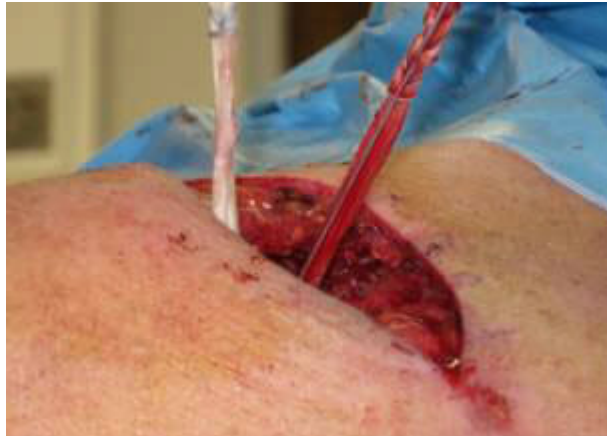
Figure 11: The graft is passed through the pre-drilled holes in the collar bone.

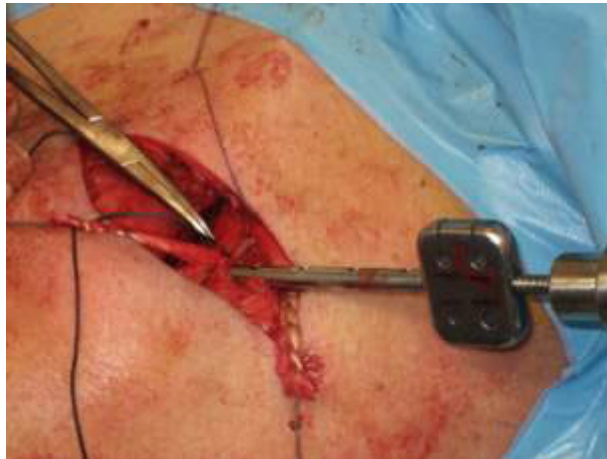
Figure 12: The graft is fixed in place with special screws with mechanical properties similar to natural bone.

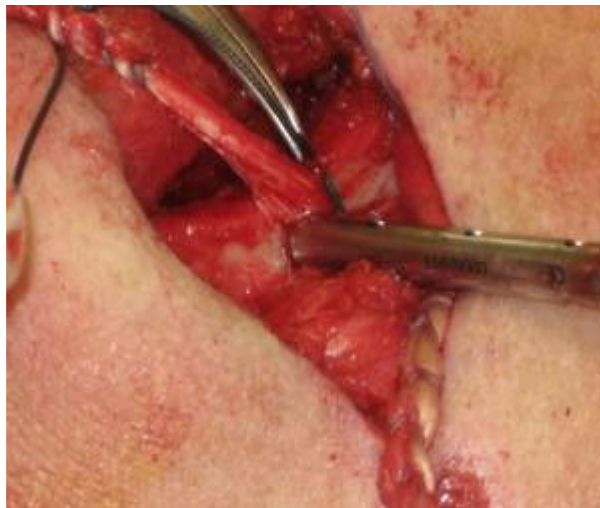
Figure 13: The screw is seated flush to bone.

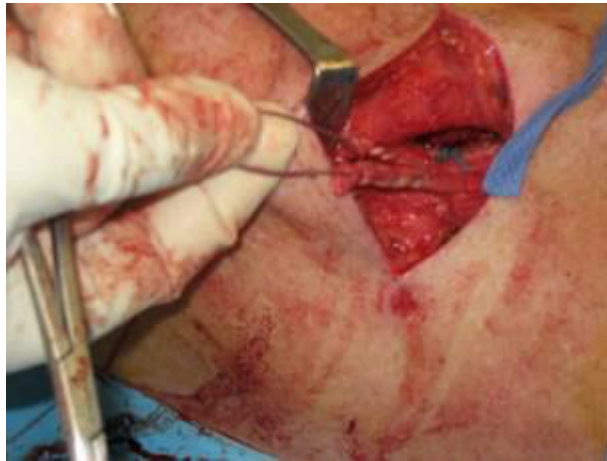
Figure 14: Once the coraco-clavicular ligament grafts are set and secure, the graft ends are tensioned and pulled laterally to repair the ligaments between the acromion and the clavicle.

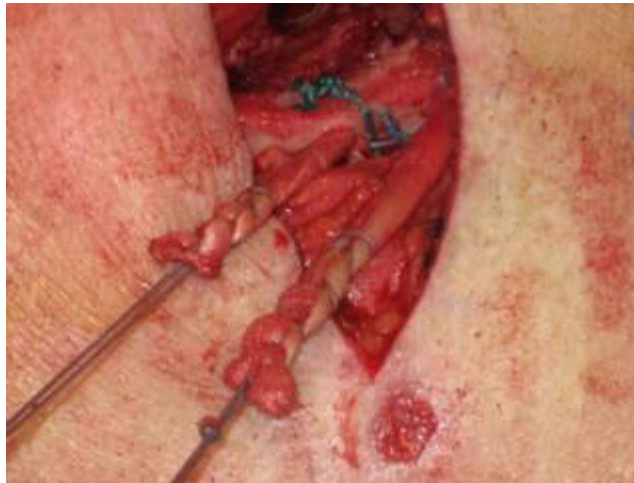
Figure 15: Close up of the grafts passing out of the drill holes.

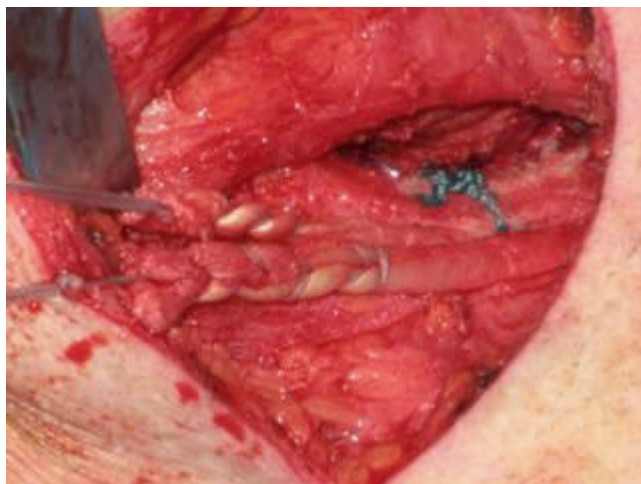
Figure 16: Positioned toward the AC joint.

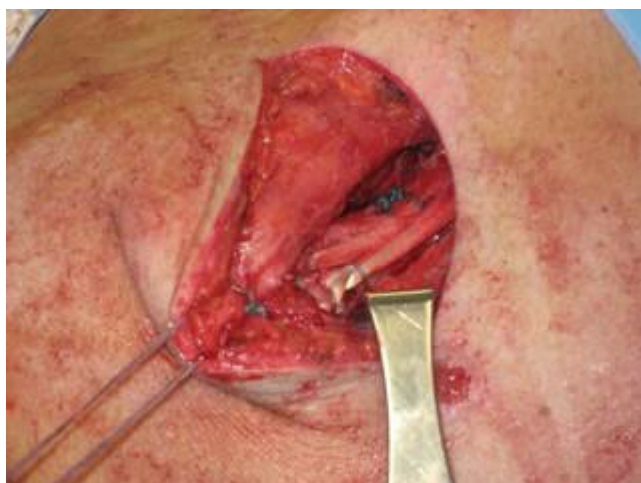
Figure 17: Graft limbs secured to the acromion.

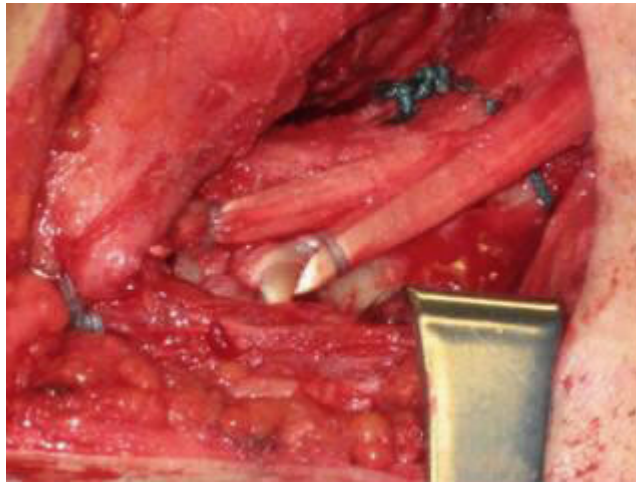
Figure 17A: Close up of complete four ligament repair.

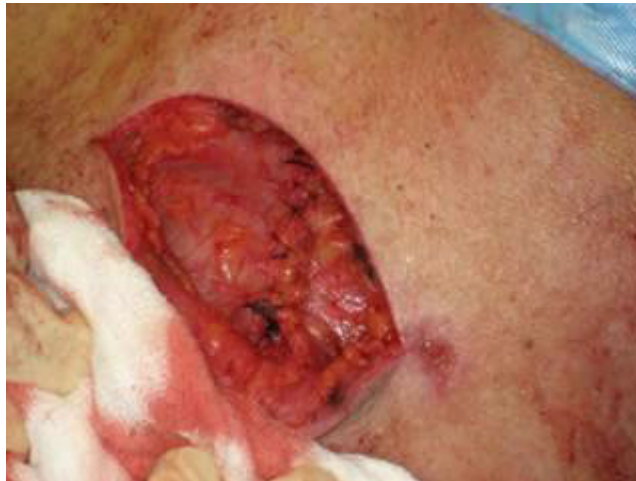
Figure 18: Closure: Deltoid- Trapezius Muscle repair.

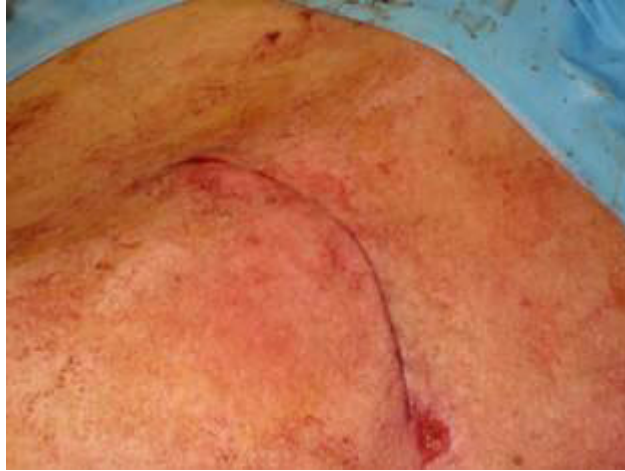
Figure 19: Skin closure, repair completed.

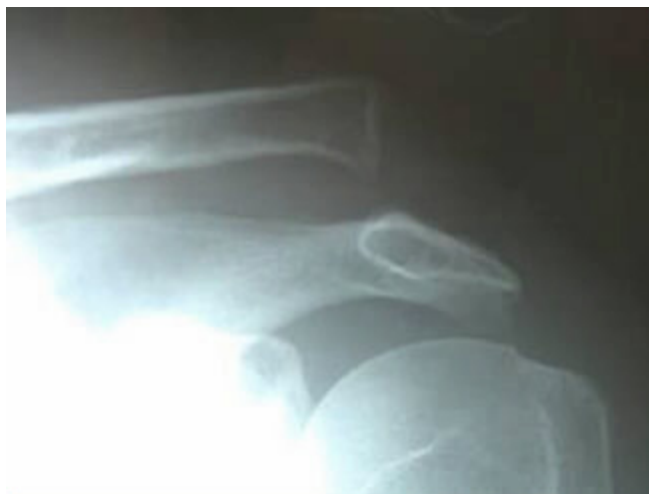
Figure 22: AC Joint Separation. Note the collar bone is significantly higher than the acromion making this a more severe separation. In this case, the bone tip is tenting the skin.

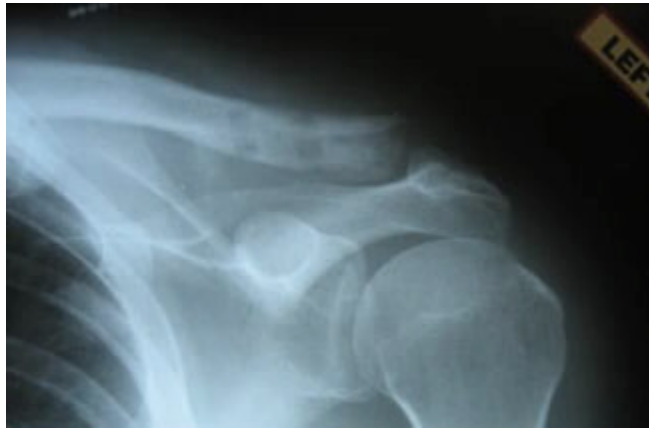
Figure 23: X-ray showing reduced AC Joint and bone tunnels after surgical repair.
